LESSONS LEARNED

Incident ID	AU.LHAPMW.ACTUAL.300124.00182112	Incident Date	30 January 2024
Incident Circumstance	Fall of Materials	Workplace Activity	Internal Façade Cladding
Operation	Liverpool Health & Academic Precinct Main Works	Issued By	Andrew Hereth

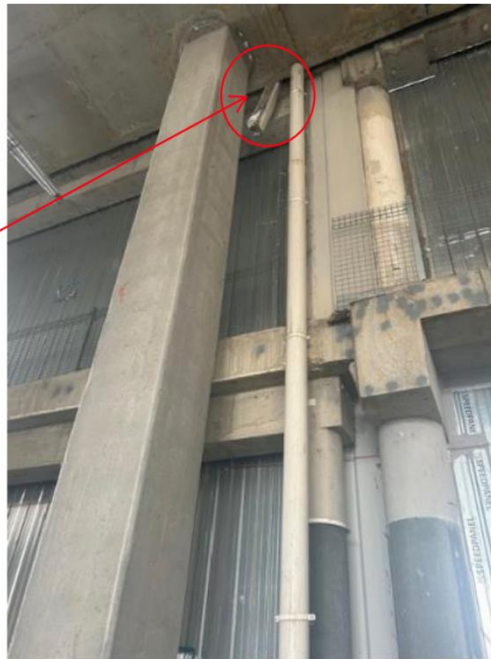
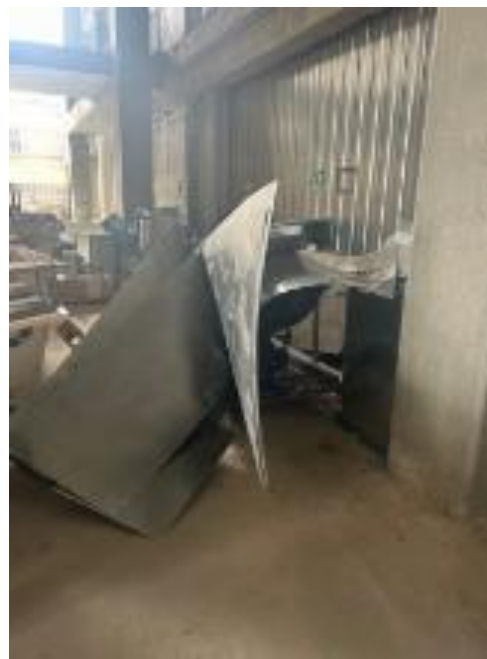
A bundle of Galva bond sheeting (25 sheets at 1200x 2400mm) fell approximately 8.4m through a fire rated movement joint and landed in a material storage zone on the level below.

The sheets were stored against an adjoining plasterboard wall and on top of the movement joint when the expansion jointing material gave way.

The expansion joint was originally covered with ply and works had commenced to install fire rated materials in the joint and permanent movement joint covers. These works were paused due to noise issues; however, the temporary ply covers were not reinstated to protect the penetration. Subsequently, the partitions contractor moved the sheets, placing them directly over the joint.

Incident location where material stacked onto fire rated joint and fell through 100mm expansion joint gap from level 2 down to ground floor

The integrity of penetration covers must be maintained and where works are incomplete, temporary protection is to be reinstated, with the work area inspected to ensure that it is safe.

Bundles of sheeting material should not be stored vertically against walls or other structures. Material should be stored flat on the ground or in an engineered storage rack.
