# LESSONS LEARNED

<b>Incident ID</b>	AU.NPAC.POTENTIAL.190722.00174752	<b>Incident Date</b>	20/07/2022
<b>Incident Circumstance</b>	Fall of Materials >2m/6ft - Dropped tool/item	<b>Workplace Activity</b>	Steel Fixing - Installation of Core Reinforcement
<b>Operation</b>	New Performing Arts Venue	<b>Issued By</b>	Scott Gilbert

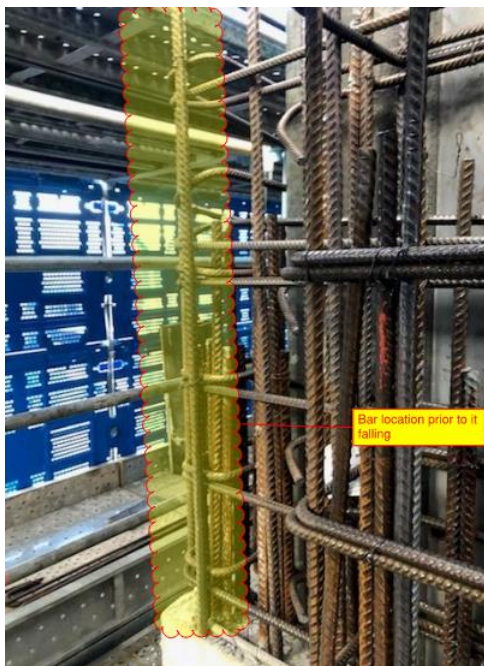
Steel fixers were carrying out steel reinforcement installation to core 2 north-east wall. They were in the process of installing horizontal bars and were using a 'dummy bar' (16mm - 1800mm long) to temporarily hold the corners. The steel fixer had noted that the 'dummy bar' had two ties holding it in place. In the process of sliding/positioning the horizontal bars, the dummy bar has dislodged and has fallen.

Bar location prior to it falling

- Gaps in scaffold around work areas are to be covered to ensure tool and/or materials cannot fall.
- Scaffolding contractor inspection documentation updated to identify if there are any gaps that require covering on the scaffold or any rectification work completed.
- Ensure scaffold contractors are aware of the Lendlease no gaps requirements.
- Works onsite are to be coordinated and workgroups are to review the builder's brief with respect to active work areas and the assessment of work areas where there is work being conducted above or below.

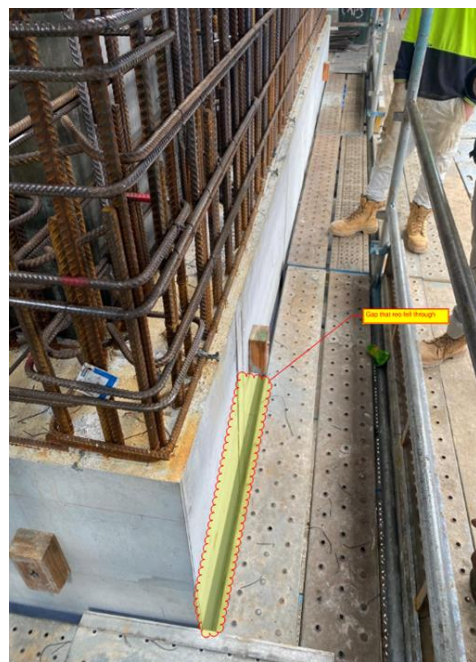
The reo bar has fallen within a 50mm gap between the core and scaffold from level 6 to level 3 (approximately twelve metres) where it has hit a scaffold handrail and deflected into the scaffold guard. The reo bar penetrated through the scaffold guard approximately 600mm.

50mm gap reo bar fell through
