LESSONS LEARNED

Incident ID	OLI00000470.POTENTIAL.030425.00186184	Incident Date	04/04/2025
Incident Circumstance	Fall of Materials >2m/6ft	Workplace Activity	Steel Kickboard Installation
Operation	Melbourne Airport Northern Infill Security Enhancement	Issued By	Andrew Hereth

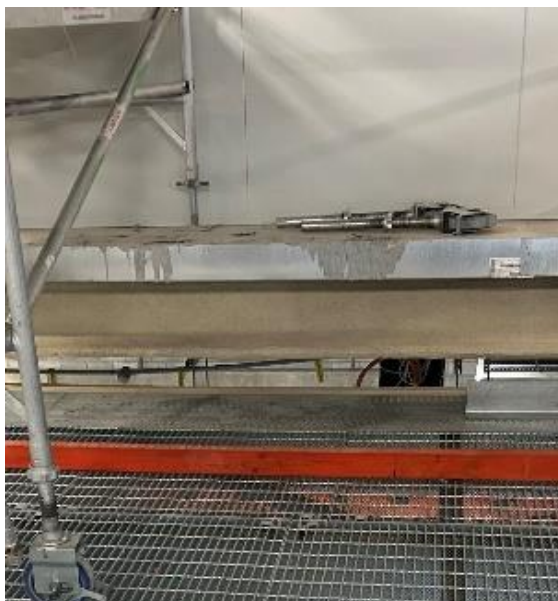
A permanent steel kickboard angle was being installed on a mezzanine level floor plate. The kickboard, approximately 3 metres long and weighing 42kg, was planned to be installed by two workers, however, during the task, one of the workers left the area to retrieve a tool.

The remaining worker continued the installation and while doing so, lost grip of the angle resulting in the kickboard falling 3.8m to the ground level, within the site boundary. There was no designated exclusion zone in place at the time. No persons were injured.

Steel kickboard angle being installed

1. Coordination of works is to be agreed between Lendlease and Subcontractors, with exclusion zone locations clearly identified and communicated to work groups. Any changes to the sequence of works are to be coordinated with Lendlease site management to ensure that changes do not impact other works and appropriate exclusion zones can be maintained or established.
2. Exclusion zones are to be established below or around all areas where there is a risk of people being struck by falling materials. The exclusion zone is to be of an adequate size and be delineated by physical barriers with clear signage prohibiting entry.
3. Workers must be inducted into their safe work methodology and ensure that all agreed controls are established before the activity commences.

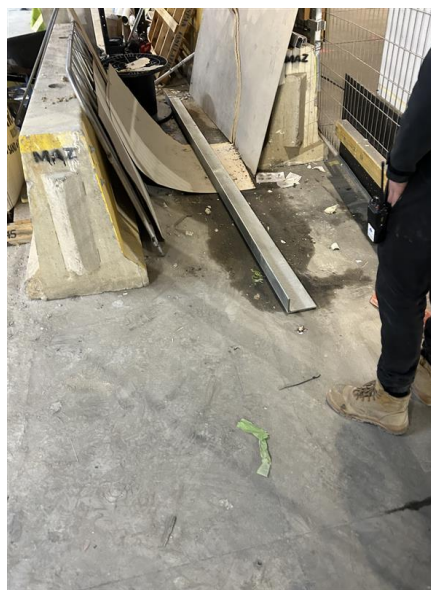
The agreed documented process required that an exclusion zone was to be established below. On this occasion, the work activity was not planned to be undertaken on this day and proceeded without coordination with Lendlease.

Location of where the kickboard angle landed
