# LESSONS LEARNED

Incident ID	AU.NSWRM.ACTUAL.251121.00170568	Incident Date	26 November 2021
Incident Circumstance	Fall of Aluminium Flashing Panel	Workplace Activity	Fixing/fixture
Operation	NSW-Reputational Maintenance	Issued By	Ian Sheils

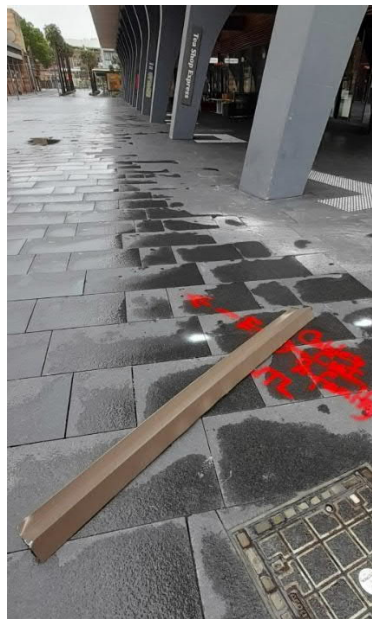
A loose aluminium flashing panel approximately 2m in length fell during a wind event from the level 9 balcony of a Darling Square Quarter apartment building (Arena) at 908/88 Hay Street. The aluminium flashing landed within a public area. The exact cause of the fall of the flashing has not been determined but it was either not fitted correctly at the installation phase or was dislodged due to a rope access technician standing on it during earlier building maintenance works. There were no injuries and at the time of reporting, Lendlease are not aware of any members of the public that were in the area at the time of the event.

Photo: fallen Façade flashing

1. A mechanical fixing to be added in addition to the original 'clip-in' design of the flashing.
2. At the design stage, the Façade cleaning, maintenance, and access strategy must consider locations where loads will be applied.
3. A working live load of 1.1kN is required to minimise the risk of the extrusions dislodging due to a rope access technician standing on it and to accommodate live loads in accordance with AS 1170.1
4. Project teams must review and monitor the implementation of the [CiDD Alert for 'Wind effects on Building and Infrastructure Elements](#).
