LESSONS LEARNED

Incident ID	AUST.CI.BUI.NSW.2.2.POTENTIAL.060624.00183663	Incident Date	07/06/2024
Incident Circumstance	Fall of Materials – Façade Glass Stitch Plate	Workplace Activity	Façade Installation
Operation	Martin Place Metro – North Tower	Issued By	Andrew Hereth

Description of Incident

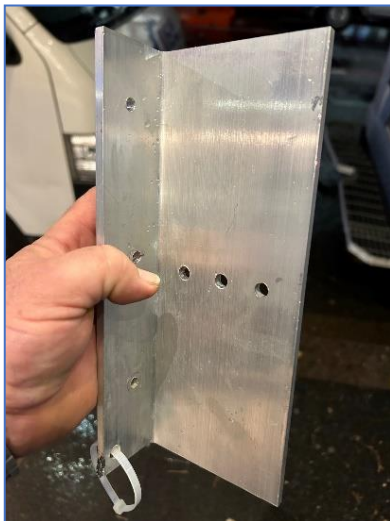
The incident investigation identified that pilot holes should have been drilled through the 8 mm aluminium mullion fin extension and it was unclear if this requirement was implemented during installation. It was found that the screws sheared at the head post installation and the most likely cause was over-torquing of the screws when affixing the stitch plate. This could have occurred due to lack of an adequate sized pilot hole, over-torquing the screw fixing, or a combination of both.

Splice Plate to secure glass panel

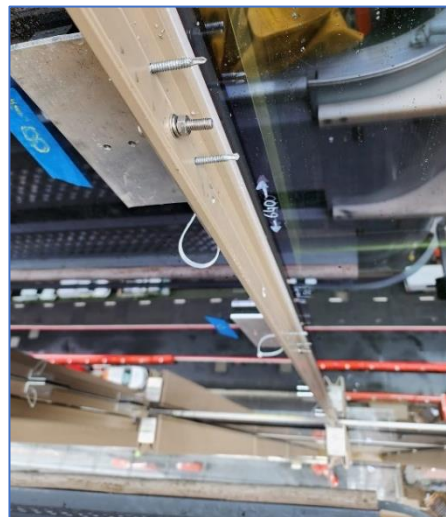
M8 Bolt fixing installed as a secondary measure
