LESSONS LEARNED

Incident ID	AU.OSHR2T.POTENTIAL.090323.00178174 AU.OSHR2T.POTENTIAL.190423.0017873	Incident Date	9 th March 2023 19 th April 2023
Incident Circumstance	Fall of Materials	Workplace Activity	Hoists – working at height
Operation	One Sydney Harbour	Issued By	Phill Smith

Description of Incident

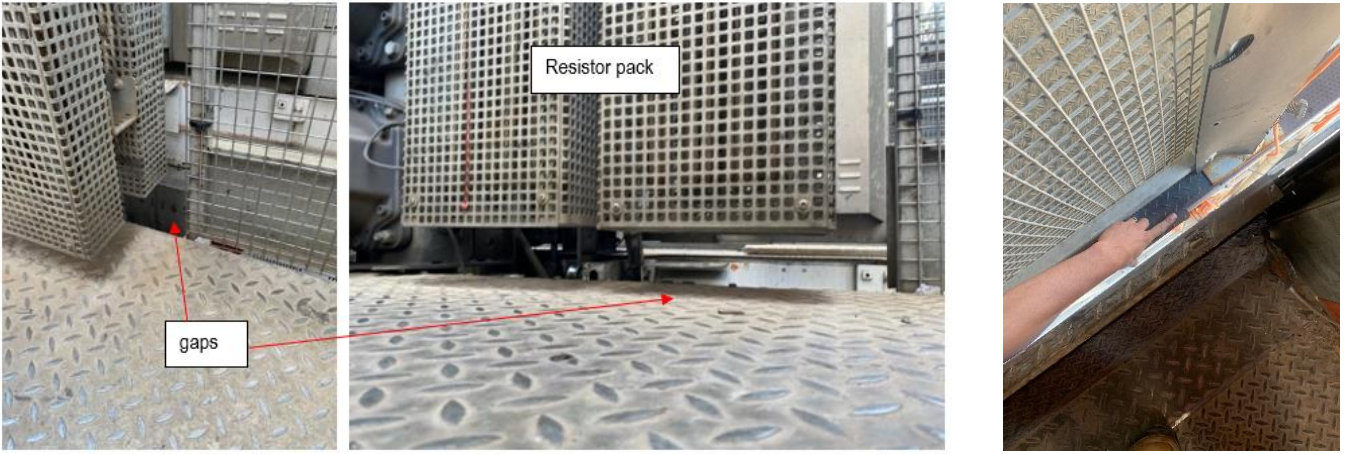
An Alimak hoist retaining pin (50mm x 20mm) weighing 130g that is used to secure a tie section between the hoist car and the hoist common tower has fallen from 57 levels and landed on ground level inside Gate 6. An Alimak hoist technician was working on top of the hoist car installing the hoist tie. The technician has reported that he noticed the retaining pin that had been placed on the floor of the hoist car roof was missing. Upon investigation it was found that the pin had been kicked through a gap in the side of the hoist car roof encapsulation.

The technician had two ring spanners with him, and he reached between the gap between the door and the gate to check the spanner sizing against the rolling bar nut external to the hoist. The technician then went to put the ring spanners back into his pocket. One spanner went into his pocket but the other missed his pocket and fell down the side of his leg. The spanner fell into the gap in the door threshold as the landing plate was raised due to the bi-parting doors being partially open.

Examples of gaps around resistor packs on top of hoist cars and between bi-parting doors and hoist gates.

- During procurement and installation, the design and quality of hoist car roof encapsulation must ensure there are not gaps in kickboards and handrail mesh.
- Adequate storage tray's should be fabricated and installation on top of the hoist car roof for securing tools and materials.

- Due to the inaccessibility of a hoist car roof, pre-inspection and ongoing monitoring should be conducted to establish and maintain a standard of encapsulation.

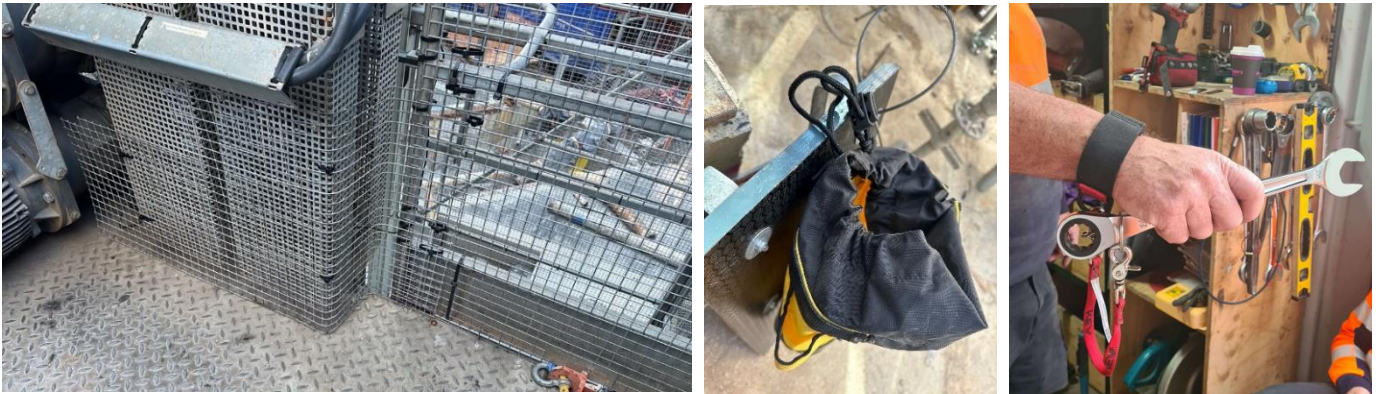
Examples of encapsulation around resistor banks, securing tool bag and ring spanner anchor with tether.

- The methodology for working on hoists must include controls to secure loose objects and tools into containers, tool bags or be tethered when travelling to and from the work location and while undertaking a task.
- While undertaking a task within the hoist car when the door is open or partially open and the landing plate is not fully closed, there is a gap. All tools and materials must be tethered and stored in tool bags or containers.
- Reliance on overhead protective walkways is limited when considering potential for fall of material arc, bounce and deflection from activities conducted at elevated positions. Exclusion zones should be of adequate size when working on hoist cars.
- Work on hoists that cannot be done by parking the hoist at lower levels can be scheduled at non-peak times to allow larger exclusion zone establishment and coordination.
