# LESSONS LEARNED

Incident ID	AUST.CI.POTENTIAL.270923.00180761	Incident Date	27/09/2023
Incident Circumstance	Fall of Materials - Caulking Gun Cartridge	Workplace Activity	Façade Installation
Operation	Martin Place Metro – South Tower	Issued By	Andrew Hereth

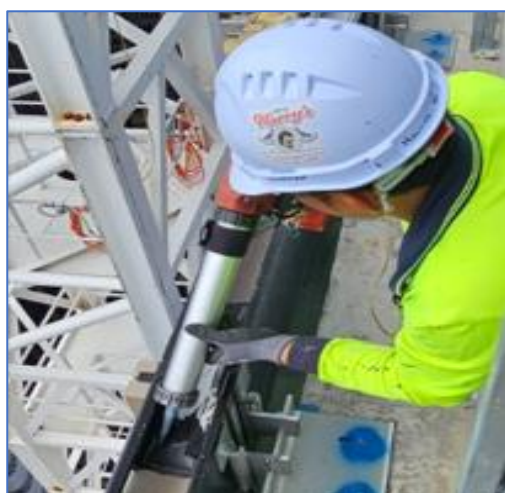
The façade subcontractor was sealing a splice plate on the Level 14 façade when the caulking gun cartridge dislodged from the caulking gun. The cartridge fell approximately 65m landing outside the established exclusion zone for the planned activity.

The caulking gun was tethered, however, the caulking cartridge was not.

Tether being used to caulk the splice plate.

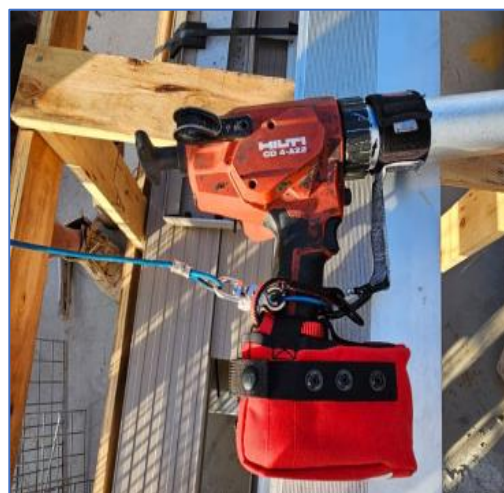
Post incident: tether designed to capture all components of the tool.

Tethers/lanyards must be used to tie off tools, equipment and materials when working at height and where the area is not fully enclosed, or where tools or objects are required for use outside of the perimeter protection.

Consideration should be given to all components of the tool / equipment where, if disengaged can present a fall of material risk.
